TECHNICAL DIAGNOSTIC ANALYSIS  
OF LRAPP TEST BED PROGRAM  
FAILURE (U)

2 August 1971

Sponsored by: Office of Naval Research

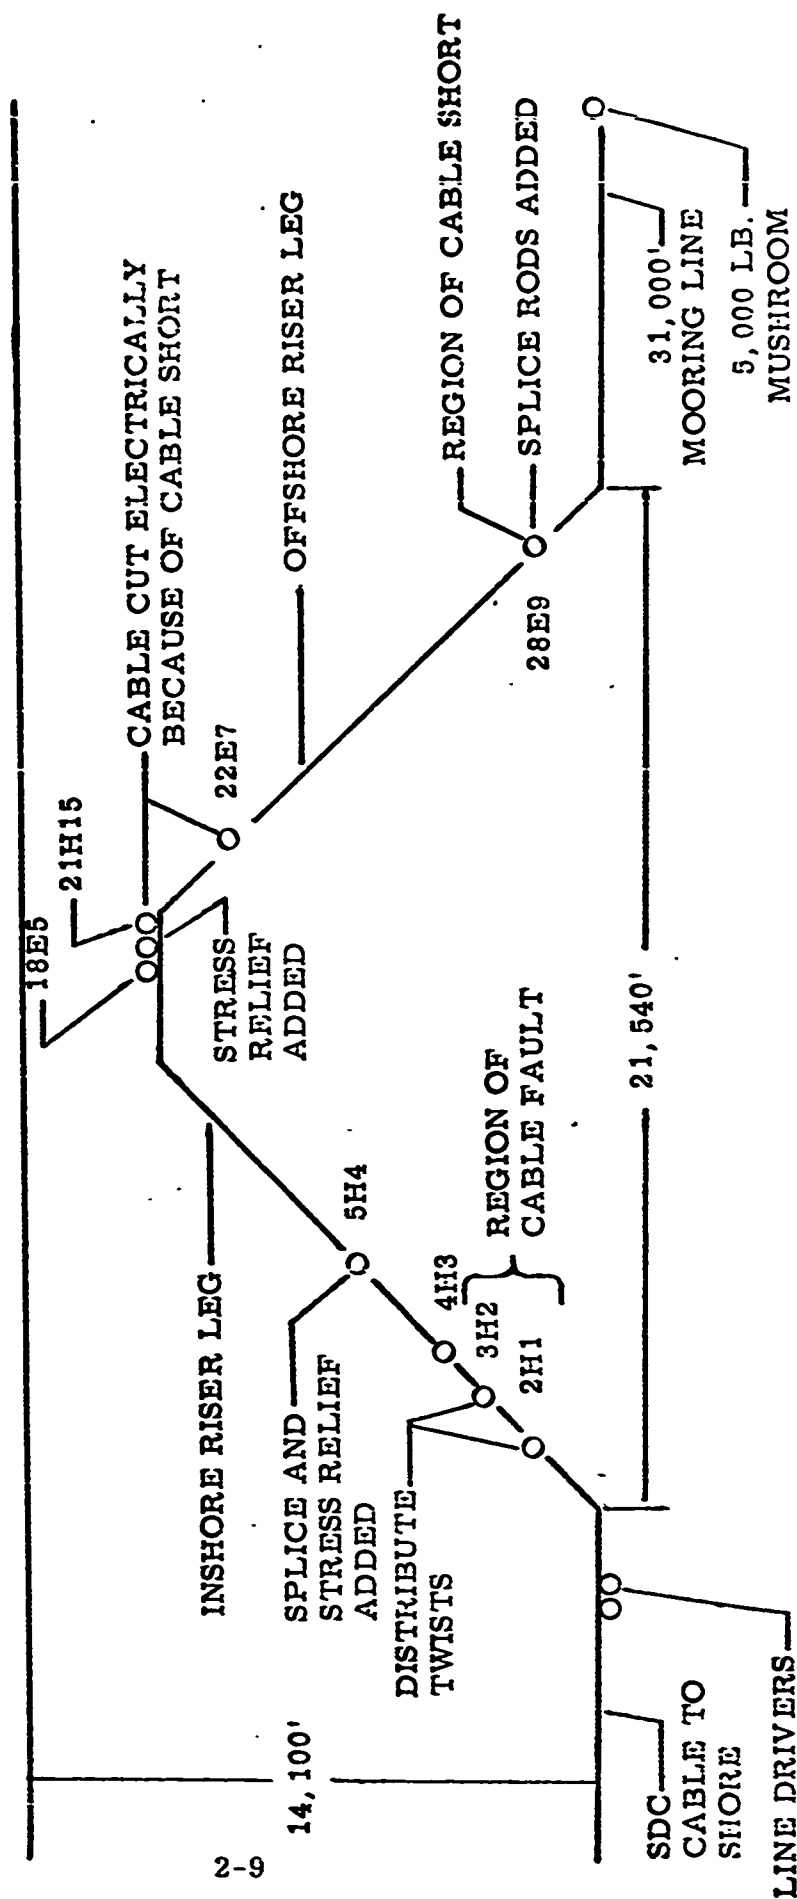
FIGURE 2. LOCATION OF KINKS AND TWISTS

(U) At the time of implantment, the Array cable contained several straightened and reinforced hockles, a splice, and several points at which twists had occurred but were not permitted to become hockles. These known defects in the cable are shown in Figure 2 and listed in Table 3 (Reference 34). Table 3 also shows the nature and cause of the defect and the remedial action taken at the time.

LOCATION OF DEFECT	NATURE & CAUSE OF DEFECT	REMEDIAL ACTION TAKEN
Below Station 28E4 2178' above outboard anchor*	Outer armor wires of cable distorted due to hockle in cable tank	Cable straightened, armor realigned. 24" PLP splice rods placed over distorted armor.
Outboard of Station 22E7 7500' above outboard anchor	Internal short between coax conductors. Believed to be at hockle near 28E9.	Electrical cable cut; Fault Finder and resistance measurements made to locate short.
Inboard of Station 22E7	Mention of minor cable kink in rough logs. Details not clear.	No action taken
Station 21H15 14,541' above outboard anchor	Cable electrically cut and terminated outboard of 21H15 because of short.	Array terminated by molding. Outboard leg electrically eliminated from array.
Outboard of Station 18E5 770' from outboard end of horizontal span	Armor wires distorted due to hockle in cable tank.	Strain relief added using cable stoppers and wire rope sling.

Outboard of Station 5H4 7700' above inboard anchor	Armor wires severely distorted due to hockle in cable tank.	Cable cut and respliced. Rearmored with 13' PLP splice rods. Wire rope strain relief added.
Outboard of Stations 4H3, 3H12 and 2H11	Twists occurred in cable but did not form into hockles. No distortion of armor noted.	Twists removed from cable by bringing bight out on deck.

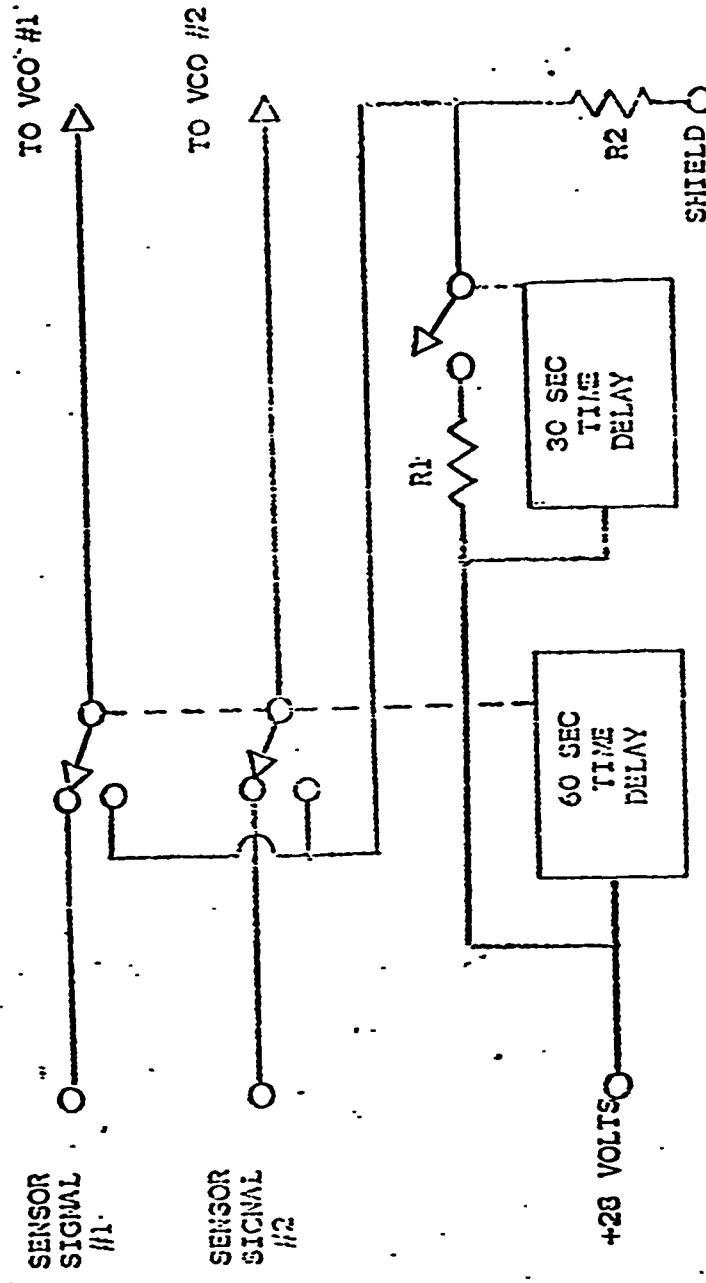
FIGURE 5. CALIBRATION BOARD AND RELAYS

reliability. Two major weak points exist within this unit. First, the relays that were used required high current, were selected from on-hand relays at NUSC, and were not of sufficient reliability or quality to be used in a system with a projected 3-5 year life. The second weak area was the selection of the ceramic filters for command tone detection. These filters are extremely critical to shock and vibration which causes mechanical failure, have very broad bandwidth skirts in their frequency response which require a very delicate control of the amplitude of the command tone, and are not as selective to frequency as they should be for adequate command response. NUSC, forced by critical implantment timing, did not elect to replace these ceramic filters with more reliable products that are on the market. Since the implantment, NUSC has investigated a tuning fork driven reed relay that both replaces the ceramic filter for tone detection and the heavy current relays with a highly reliable, very accurate and sensitive decode capability. In future implantments, these new relays should be considered for use over the filters and relays used for the TEST BED.

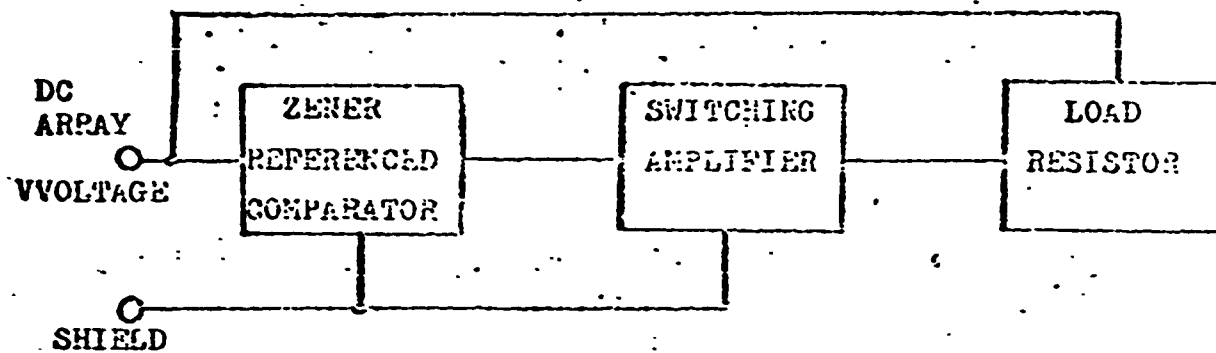
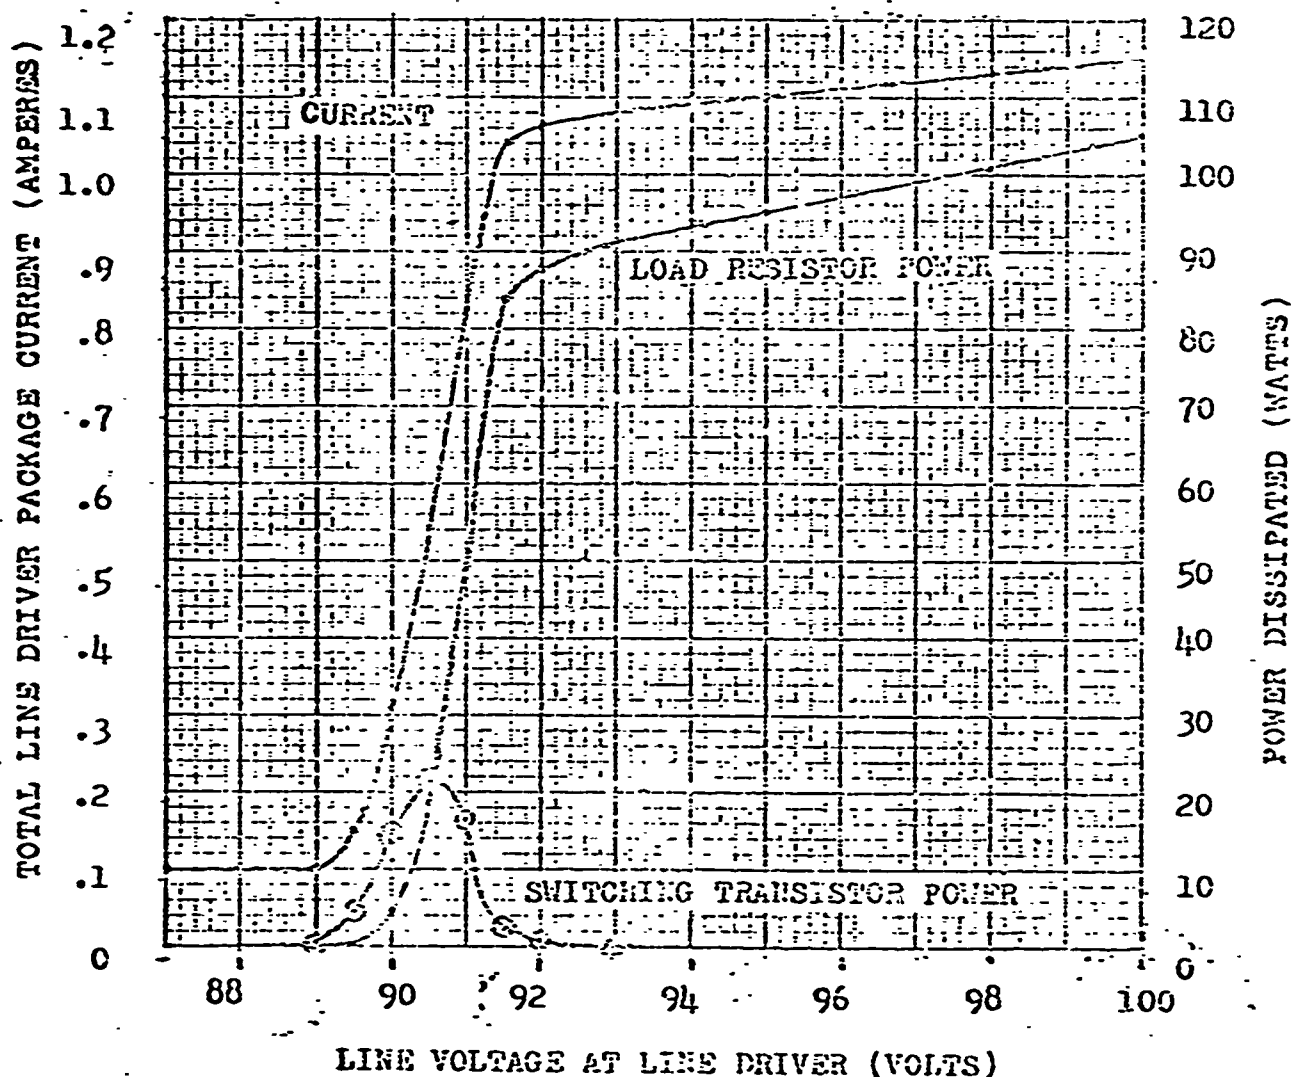
FIGURE 10. OVERVOLTAGE PROTECTOR BLOCK DIAGRAM AND LINE VOLTAGE VS POWER DISSIPATION IN THE LINE DRIVER

(U) Array damage can occur if the supply voltage exceeds 93 volts at the line driver. This high voltage condition is possible if the

(U) Because of the nature of the Array operation, DC voltage being supplied from the shore and telemetry signals being sent back through the common coax cable and because of the high voltage loss due to the current drain of the Array through the long coax cable, protection had to be built into the line drivers so that operator control through the command and control networks could not damage or destroy the overall Array. Again, good basic engineering was used. The use of a switching amplifier, a load resistor and a zener reference diode is considered the best protection that could have been given to the

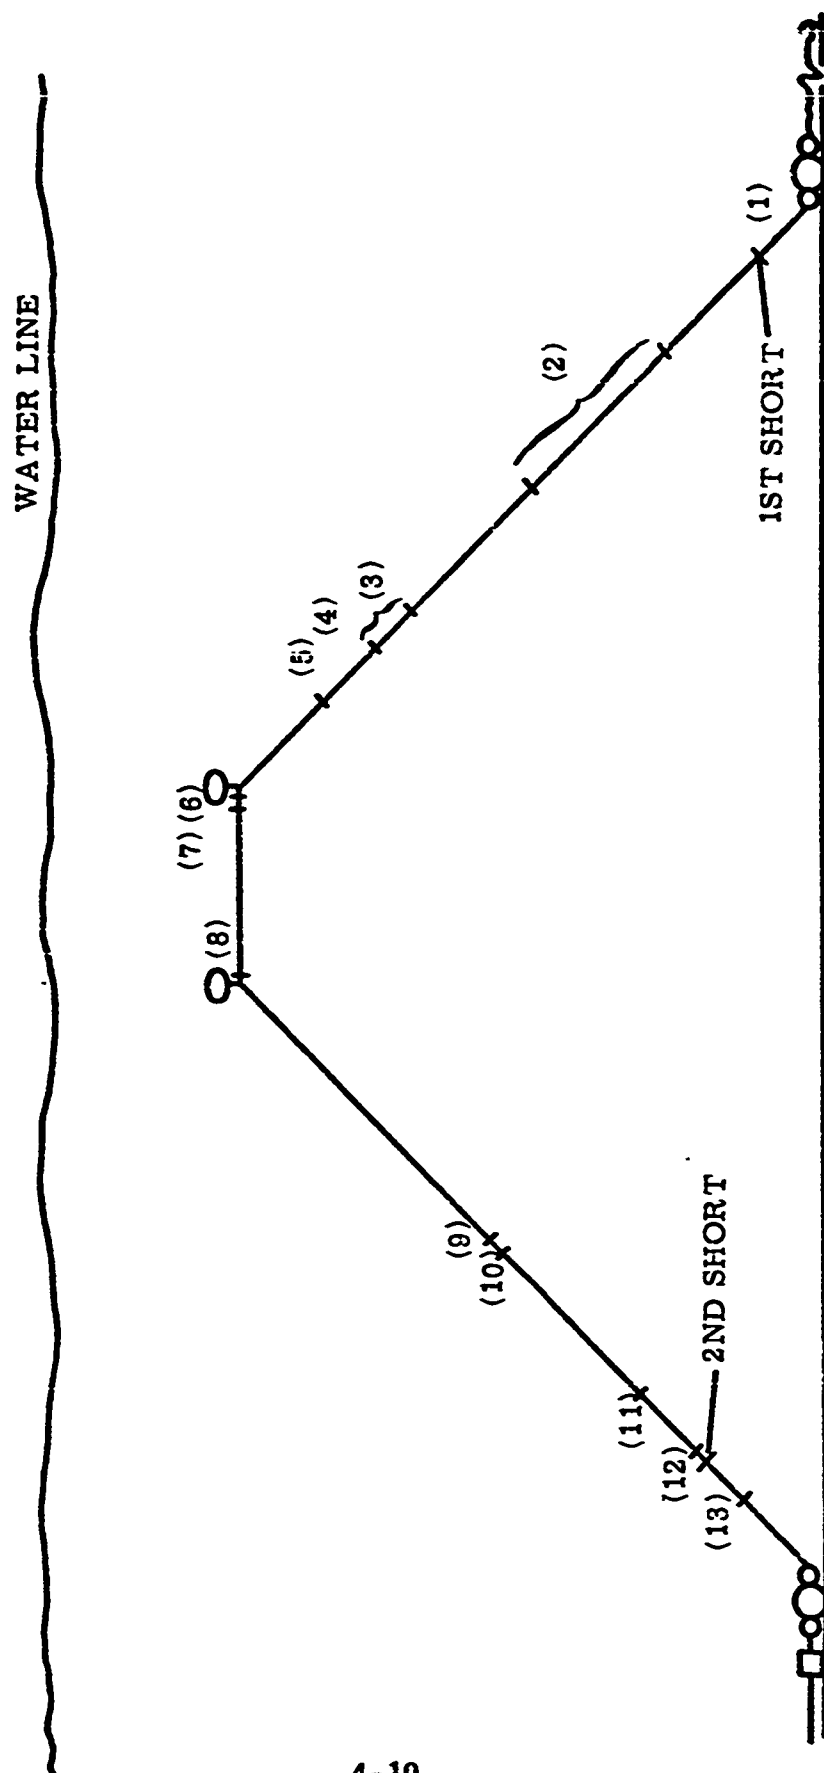
FIGURE 12. LOCATION OF IMPLANT IRREGULARITIES AND ELECTRICAL SHORTS

(C) At 0605 on 3 December, while deploying the Array, package 22E7 was about to be deployed, a short in the Array was experienced. This proved to be a direct short circuit (no sea cell) which could not be fuse cleared, and caused the Array to be electrically decoupled at packages 22E7 and 21H15 so that the remainder of the Array could function.

(U) One major problem was encountered in the deployment of the seaward riser leg. A hockle developed just prior to instrument package 28E9. This hockle was straightened and splice rods added and deployed overboard as there was no indication of electrical failure. As instrument package 22E7 was being deployed, a short circuit was detected in the seaward riser leg. Testing seaward showed that there was an electrical short approximately in the area of 28E9. This short was proven to be a center conductor to shield short, in a sea cell.
